# **Accelerated Corrosion Results for Zinc/Nickel-Plated Automotive Parts Posttreated With Trivalent Chromate Rinse**

**ARL-TR-5361**

**September 2010**

# **Army Research Laboratory**

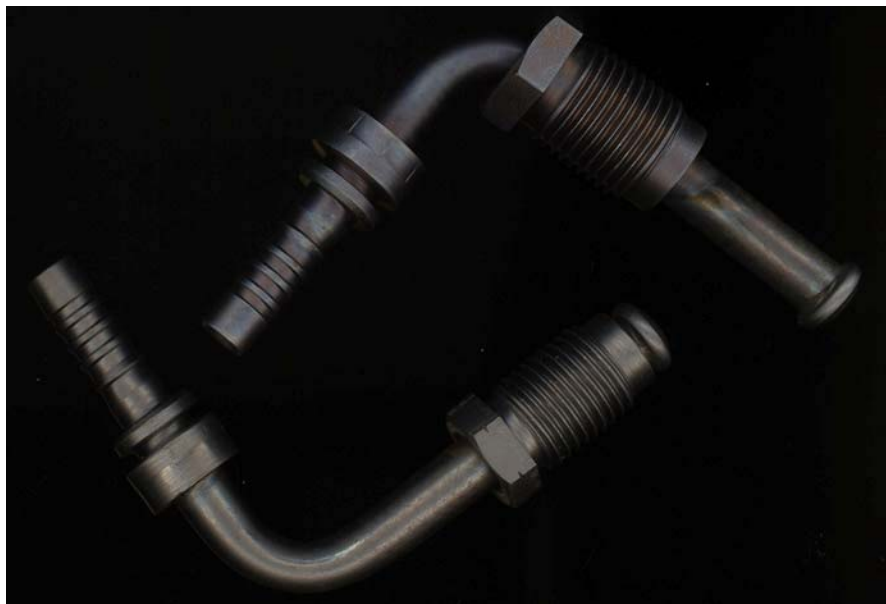
Figure 1. Brake line connector prior to exposure.

Steel parts zinc/nickel-plated and posttreated with TCP were tested using the same specification as cadmium-plated parts with a hexavalent chromium seal. For the specification SAE-AMS-QQ-P-416,<sup>4</sup> the minimum acceptable corrosion resistance criterion is that after 96 h of ASTM B 117 exposure, there should be no appearance of white cadmium corrosion products, pitting, or base metal corrosion products. The Metal Finishing Handbook cites examples of zinc-plated parts rack and barrel plated with a hexavalent chromium rinse lasting 400 and 300 h in neutral salt spray.<sup>5</sup> Similarly plated samples post treated with trivalent chromium rinse lasted 450 and 200 h in neutral salt spray, respectively. Since zinc/nickel is generally superior over steel, it is believed that plated parts surviving in excess of 336 h of ASTM B 117 exposure will exhibit “good” performance in the engine compartment of a vehicle. Similarly, parts surviving between 40 and 80 cycles of GM 9540 exposure before first evidence of red corrosion are also considered to have “good” corrosion performance. By both of these criteria, only one of these parts (part 9—a brake line connector with a sliding threaded coupling that had the lowest rating for both protocols) did not have “good” corrosion metrics. As seen in figures 1–3, this part has a complex shape, with some surfaces of the line that could have been shielded during the plating and sealing operations.

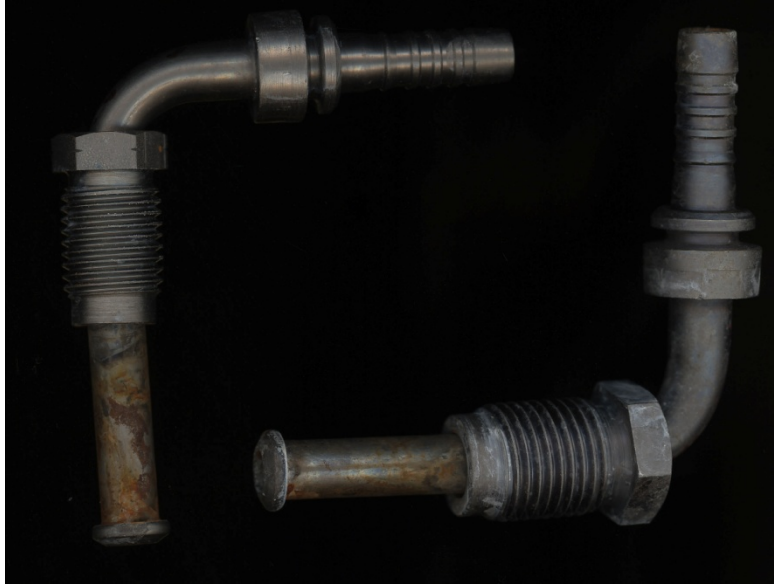
Figure 2. Brake line connector following ASTM B 117 exposure.

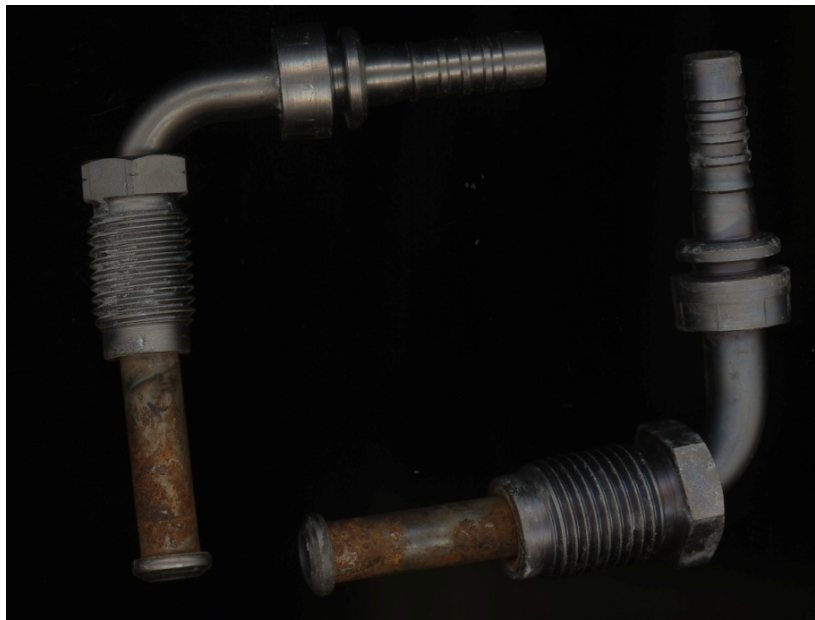
Figure 3. Brake line connector following eight cycles GM 9540 exposure.

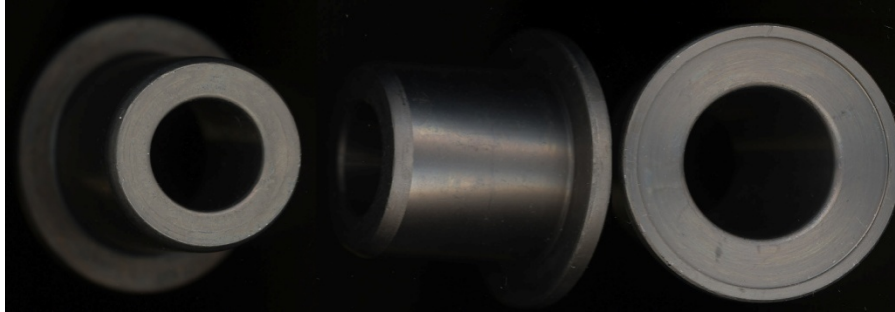
Figure 4. Bushing before exposure.

Conversely, there were seven parts that exhibited exceptional corrosion resistance during both accelerated exposure protocols. The best combined rating was for the bushings (part 7) shown in figures 4–6. This part lasted 36× the “good” criterion for ASTM B 117 and 15× the “good” criterion for GM 9540. Other parts that had exceptional performance in both exposures were the bracket (part 11, barrel plated; figure 7), the rocker arms (part 2, barrel plated; figure 8), the

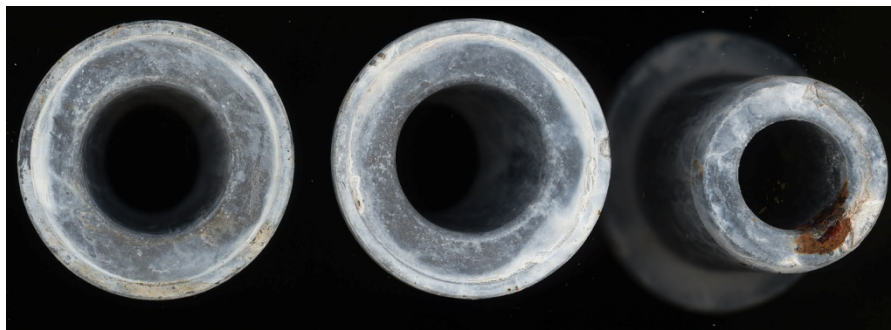
Figure 5. Bushings following 12,792, 12,624, and 10,536 h of ASTM B 117 exposure.

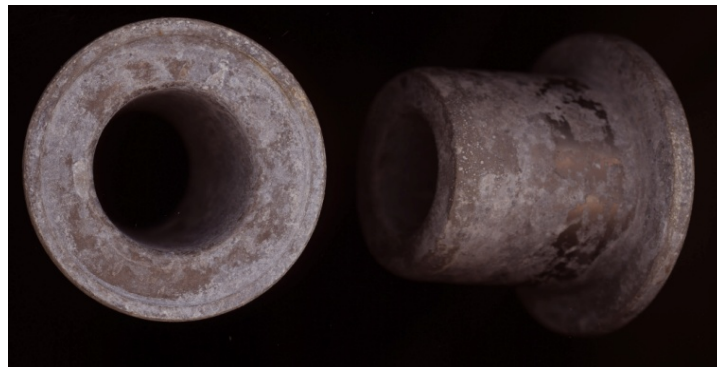
Figure 6. Bushings following 680 cycles of GM 9540 exposure.

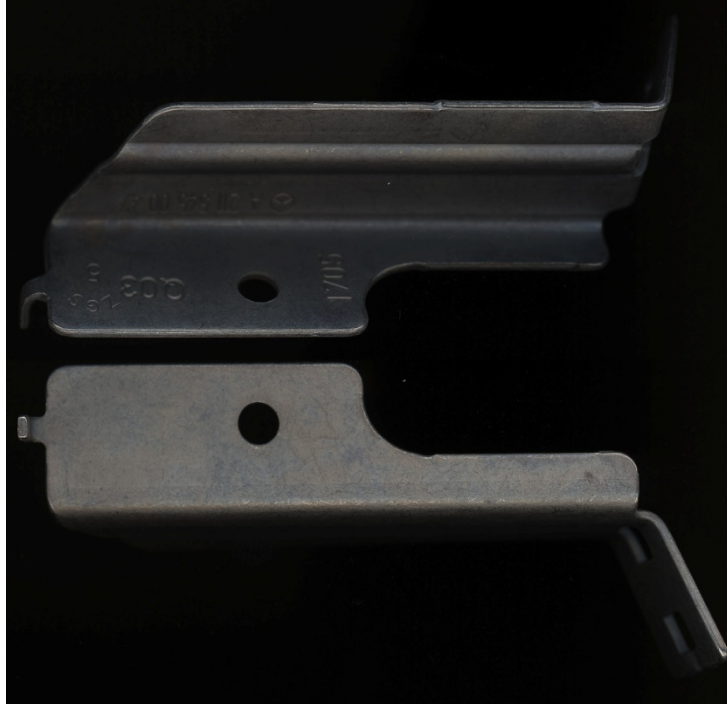
Figure 7. Bracket before exposure.

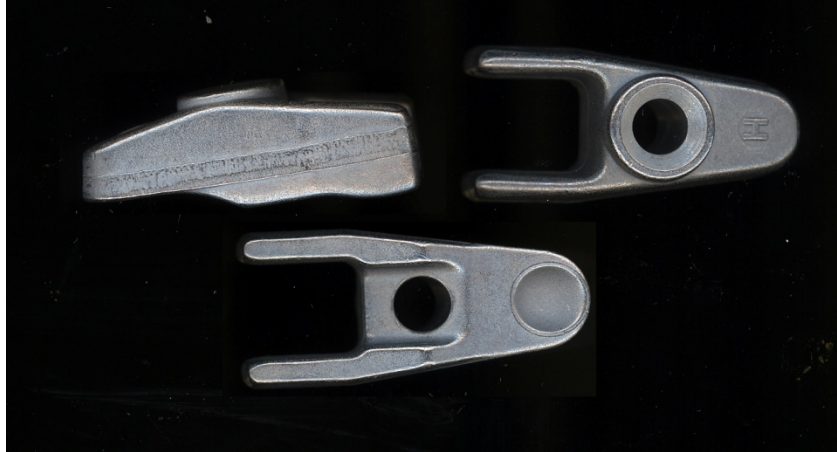
Figure 8. Rocker arms before exposure.

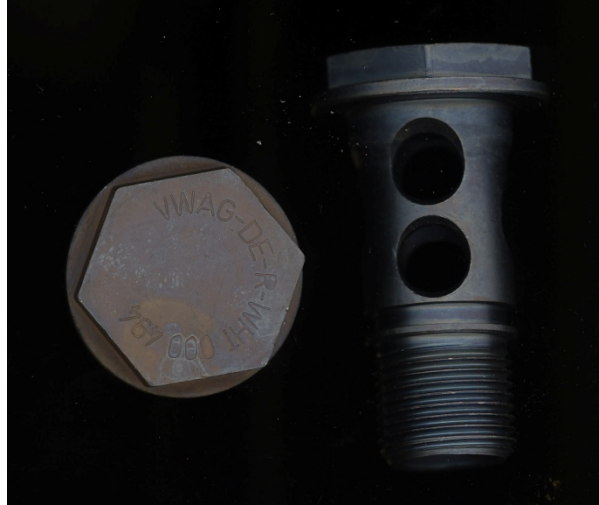
Figure 9. Hydraulic fluid diverter before exposure.

hydraulic fluid diverter (part 5; figure 9), the hex head fluid line caps (part 10, barrel plated; figure 10), the outside threaded hex head fluid cap (part 12, barrel plated; figure 11), and the fluid line part (part 3, barrel plated; in figure 12). All of these parts have relatively simple shapes that provided ample access for the plating solution and the sealer to all surfaces. For interior surfaces, the diameter-to-length ratio was large and the three threaded parts all had coarse threads; so, again, the plating solution and the sealer had ample “throwing power.”

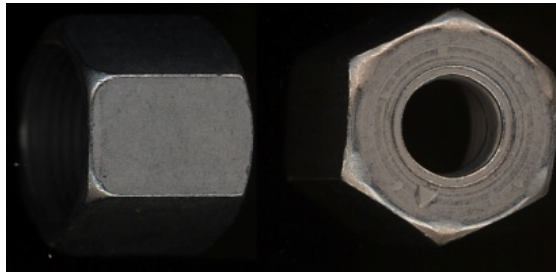
Figure 10. Hex head fluid line cap before exposure.

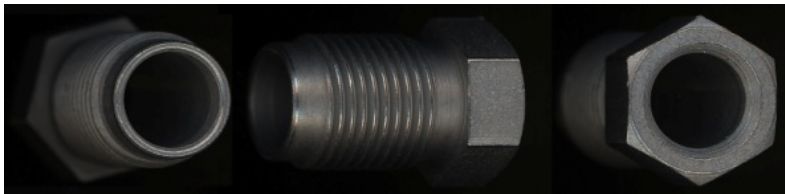
Figure 11. Hex head with outside threaded fluid cap before exposure.

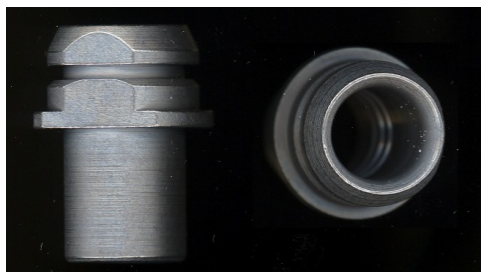
Figure 12. Fluid line part before exposure.

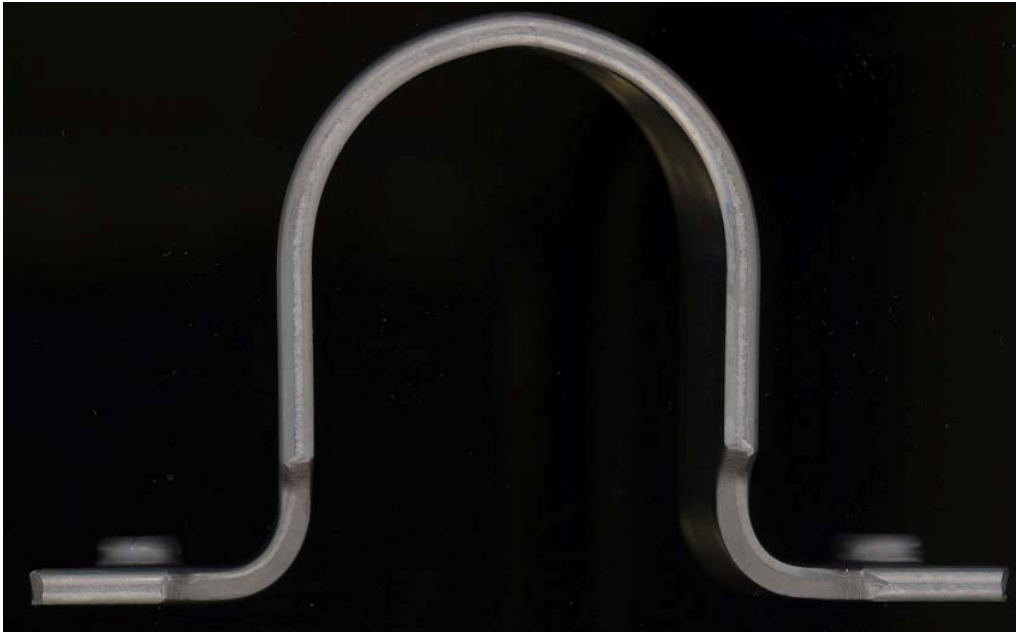
Figure 13. Threaded U-bracket before exposure.

There are three additional categories, based on performance in the two accelerated tests, that the remainder of the parts fell into. The first of these included parts that had superlative performance during ASTM B 117 exposure, whereas the GM 9540 performance was only three or four times the 40 cycle criterion for “good” performance. Both the threaded U-bracket (part 1; figures 13–14) and the Allen-keyed threaded plug (part 6, barrel plated; figures 15a and b) fall into this category. Finer threads on the bracket and a geometry that may retain chamber test fluids may have contributed to their relatively poorer performance in GM 9540.

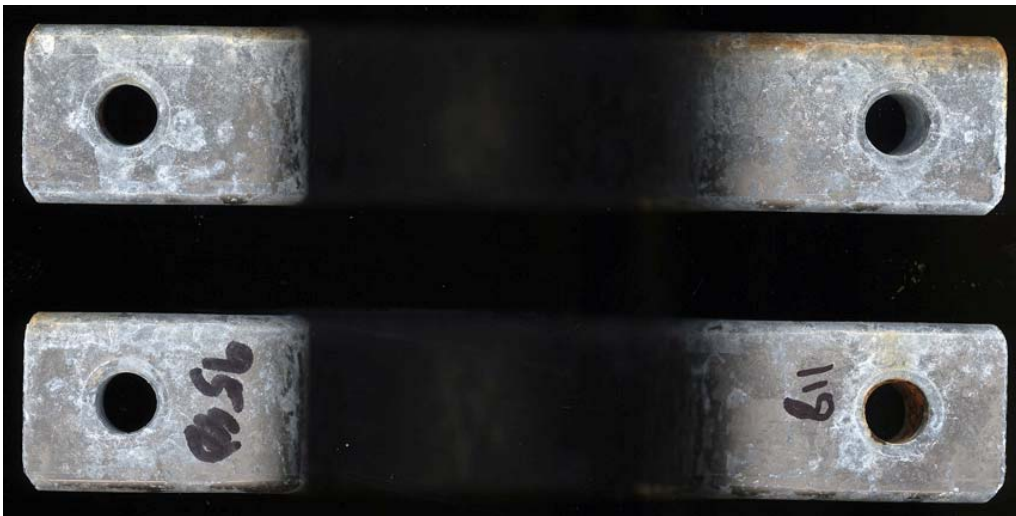
Figure 14. Threaded U-bracket following GM 9540 exposures.

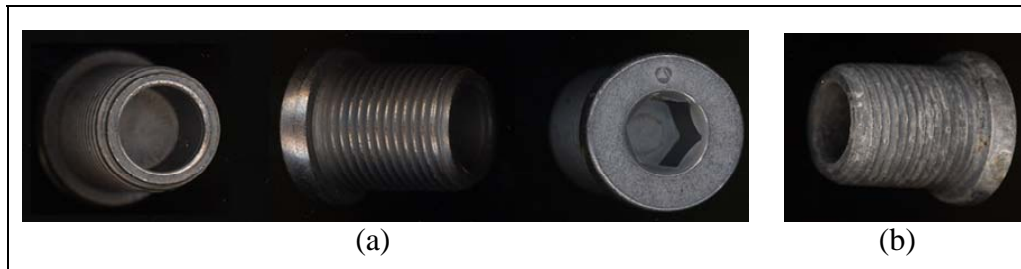
Figure 15. Threaded plug before and after 170 cycles of GM 9540 exposure.

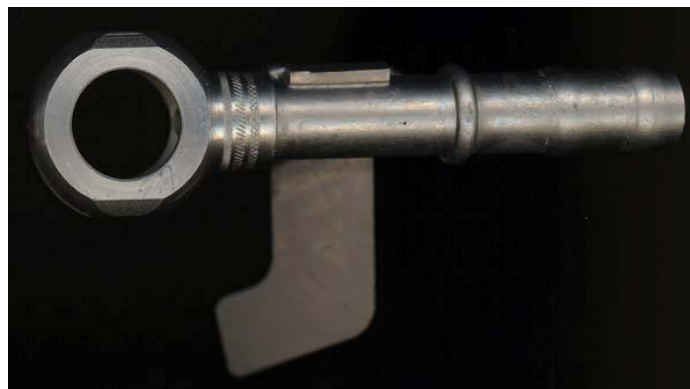
Figure 16. Unidentified component A before exposure.

The next performance category contained those parts that sustained exposures more than three times the required 336 hours of ASTM B 117 exposure, but they had only the requisite 40 cycles of GM 9540 exposure. This group included unidentified component A (part 14; figures 16 and 17), a sleeve (part 13; figures 18 and 19), fluid line (part 8; figures 20 and 21), and an unidentified component B (part 4; figures 22 and 23). In general, these parts had shapes that were more complex, with smaller diameter-to-length ratios, and two that had welds that created crevices. The three parts with a tubular component often had corrosion develop well down the inner diameter of the tube.

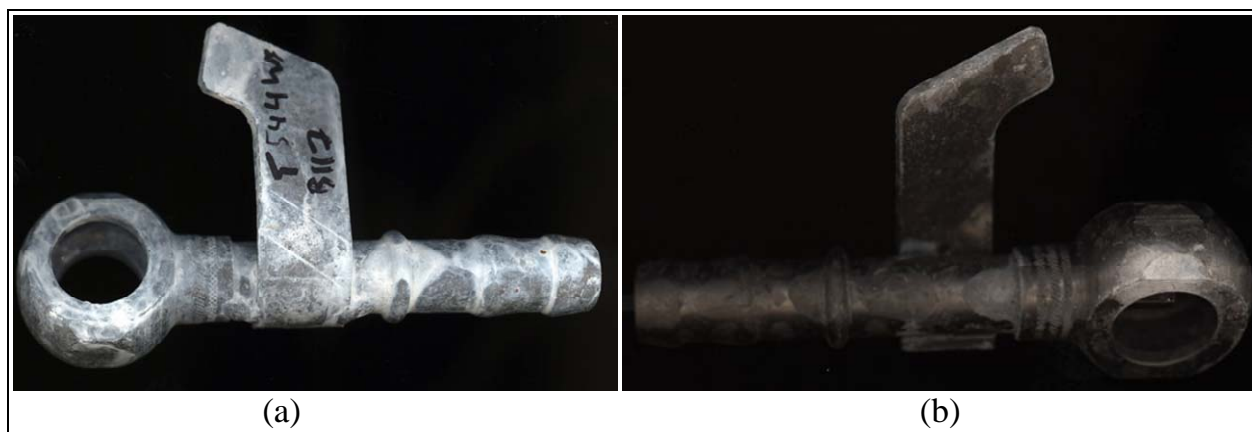
Figure 17. Unidentified component A following 5544 h of ASTM B 117 and 44 cycles of GM 9540 exposure.

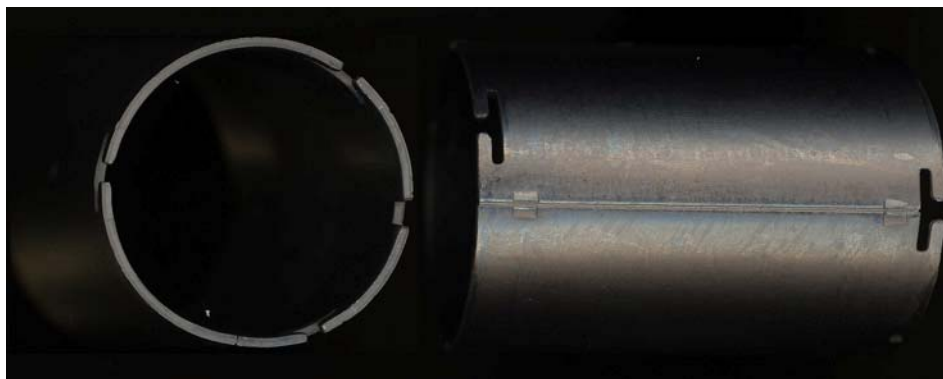
Figure 18. Sleeve before exposure.

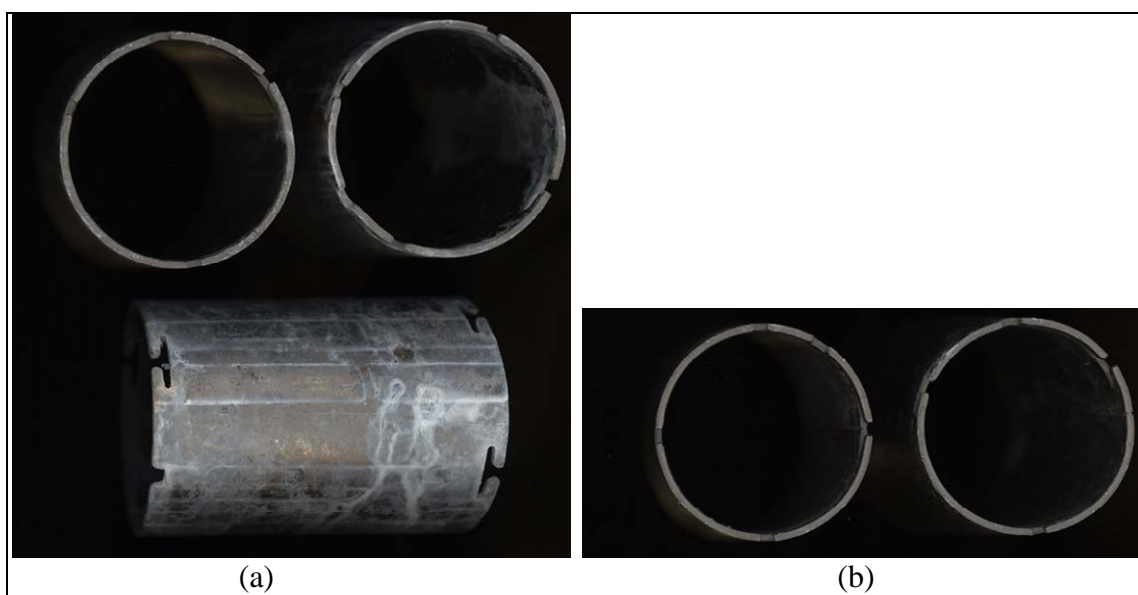
Figure 19. Sleeves following an average of 5388 h of ASTM B 117 exposure and an average of 47 cycles of GM 9540 exposure.

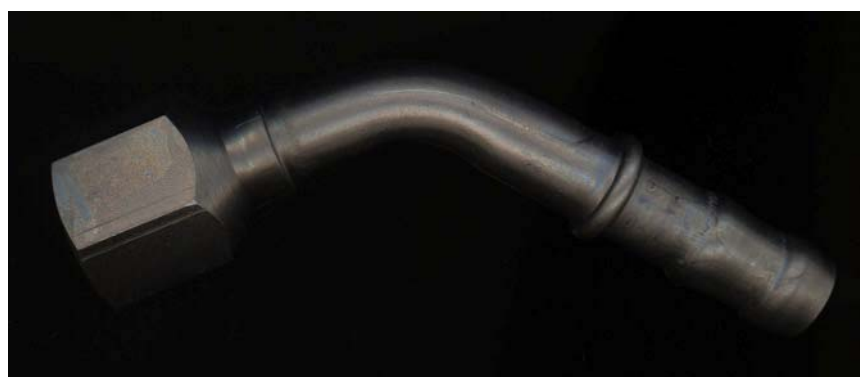
Figure 20. Fluid line before exposure.

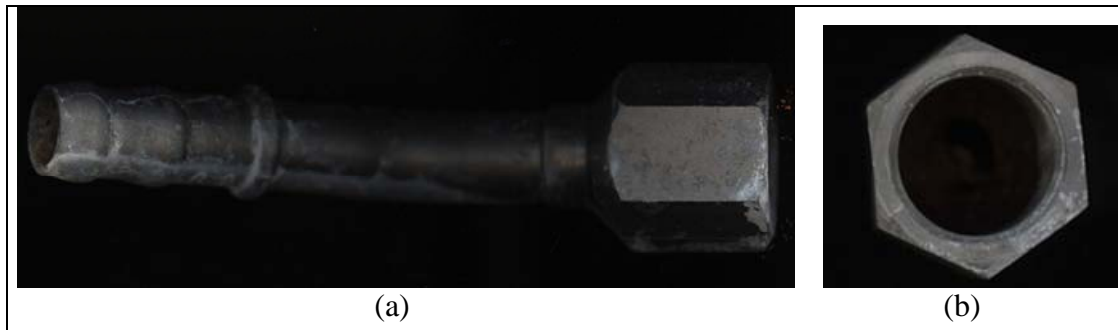
Figure 21. Fluid line following 1392 h of ASTM B 117 and following 30 cycles of GM 9540 exposure.

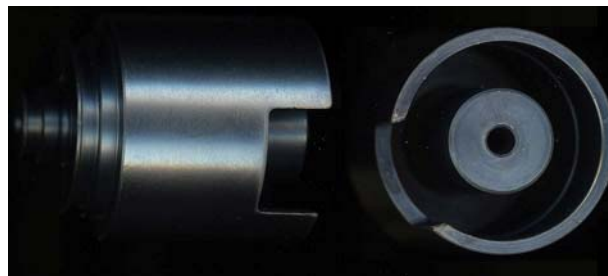
Figure 22. Unidentified component B before exposure.

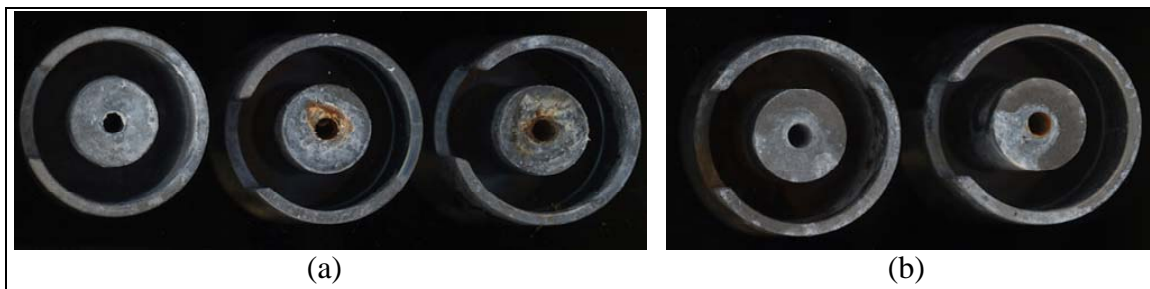
Figure 23. Unidentified component B following an average of 980 h of ASTM B 117 exposure and an average of 61 cycles of GM 9540 exposure.

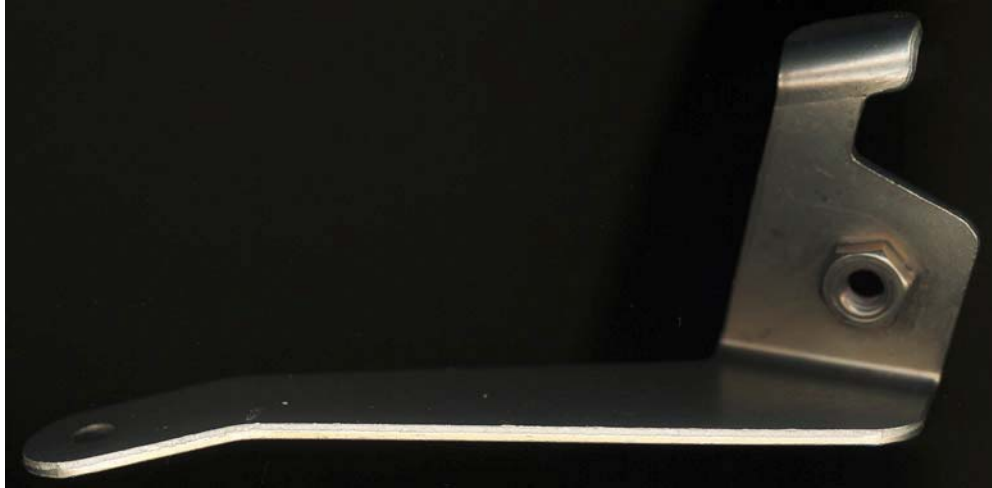
Figure 24. Bracket coated with zinc/iron before exposure.

The final category of performance included those parts that merited up to twice the “good” exposure time for ASTM B 117 exposures and were slightly substandard for a “good” GM 9540 performance rating. The three parts in this category were a bracket plated with zinc-iron (part 15; figures 24 and 25), a similarly configured bracket plated with zinc (part 16; figures 26 and 27), and a fluid line (part 17; figures 28 and 29). There does not appear to be a significant difference between the performances of the two brackets in this group despite the different plating compositions. The fluid line in this group was geometrically similar to the one in the previous group, with the main difference being that the inner diameter of this fluid line was half that of part 8. This contributed to the inferior performance during the ASTM B 117 exposure.

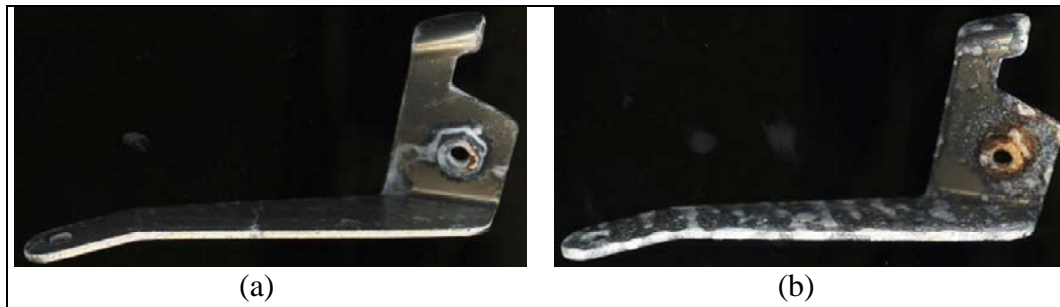
Figure 25. Bracket coated with zinc/iron following 720 h of ASTM B 117 and 27 cycles of GM 9540 exposure.

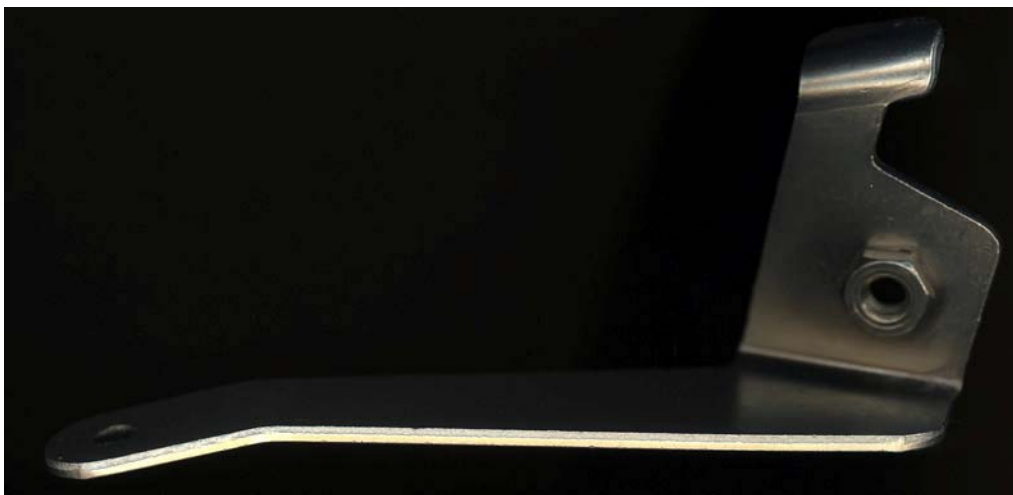
Figure 26. Bracket coated with zinc before exposure.

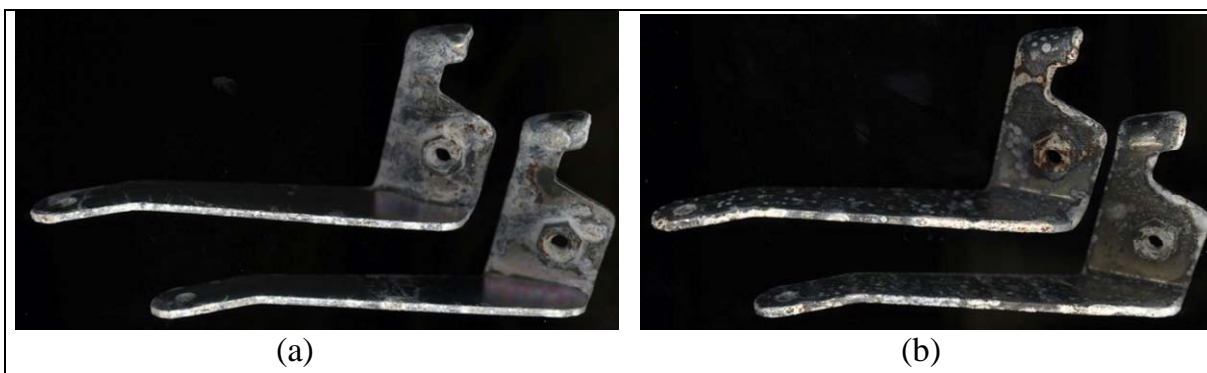
Figure 27. Bracket coated with zinc following exposure of 552 h in ASTM B 117 and 27 cycles in GM 9540.

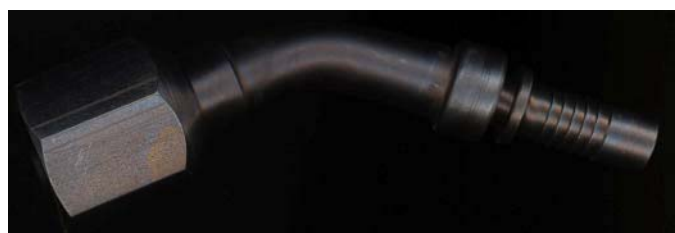
Figure 28. Fluid line before exposure.

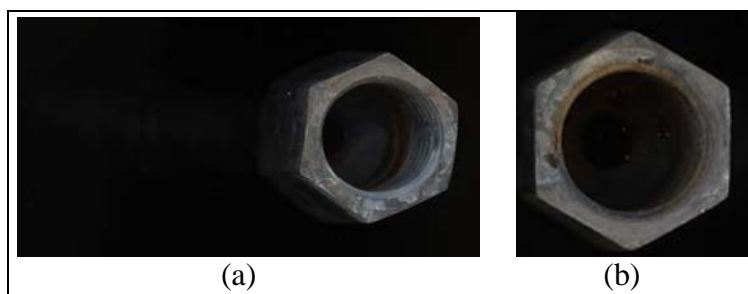
Figure 29. Fluid line following exposure of 720 h in ASTM B 117 and 21 cycles in GM 9540.
